Building 3001 Remedial Investigations Volume I - Report

TINKER AIR FORCE BASE Installation Restoration Program

TINKER AIR FORCE BASE
INSTALLATION RESTORATION PROGRAM
PROJECT NO. WWYK86-311
SITE NO. TINKER 01

PREPARED BY:
U.S. ARMY CORPS OF ENGINEERS
TULSA DISTRICT

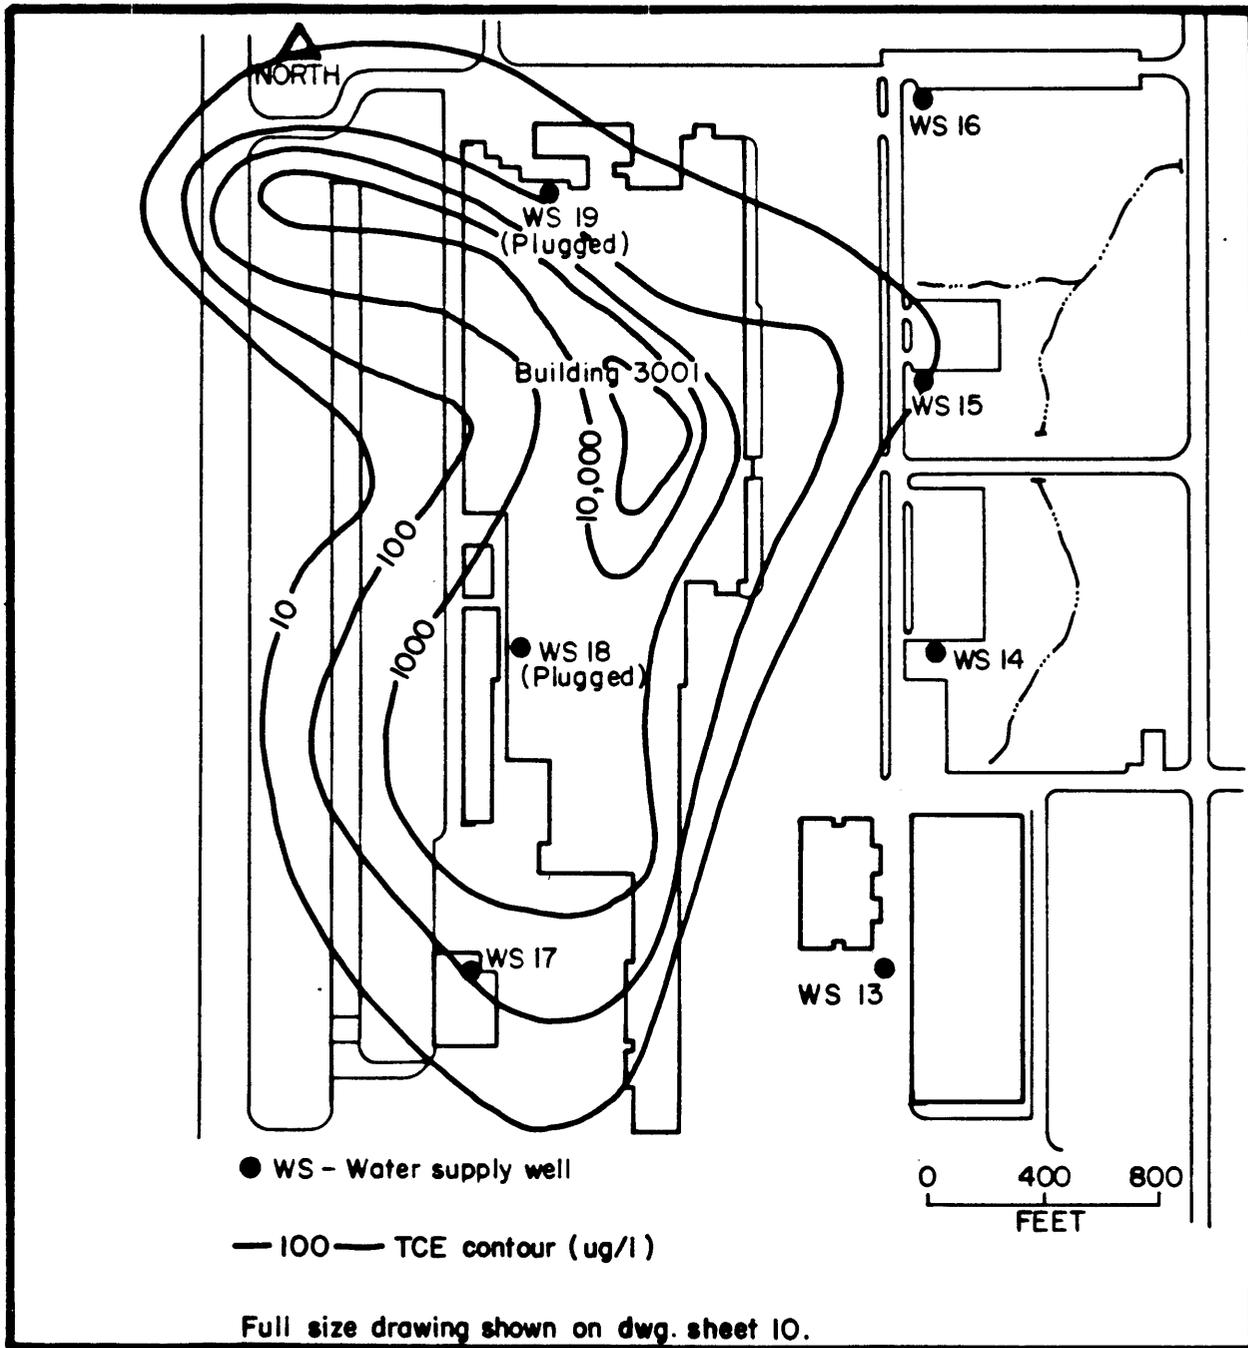
TCE PLUME IN PERCHED AQUIFER
FIGURE I-5

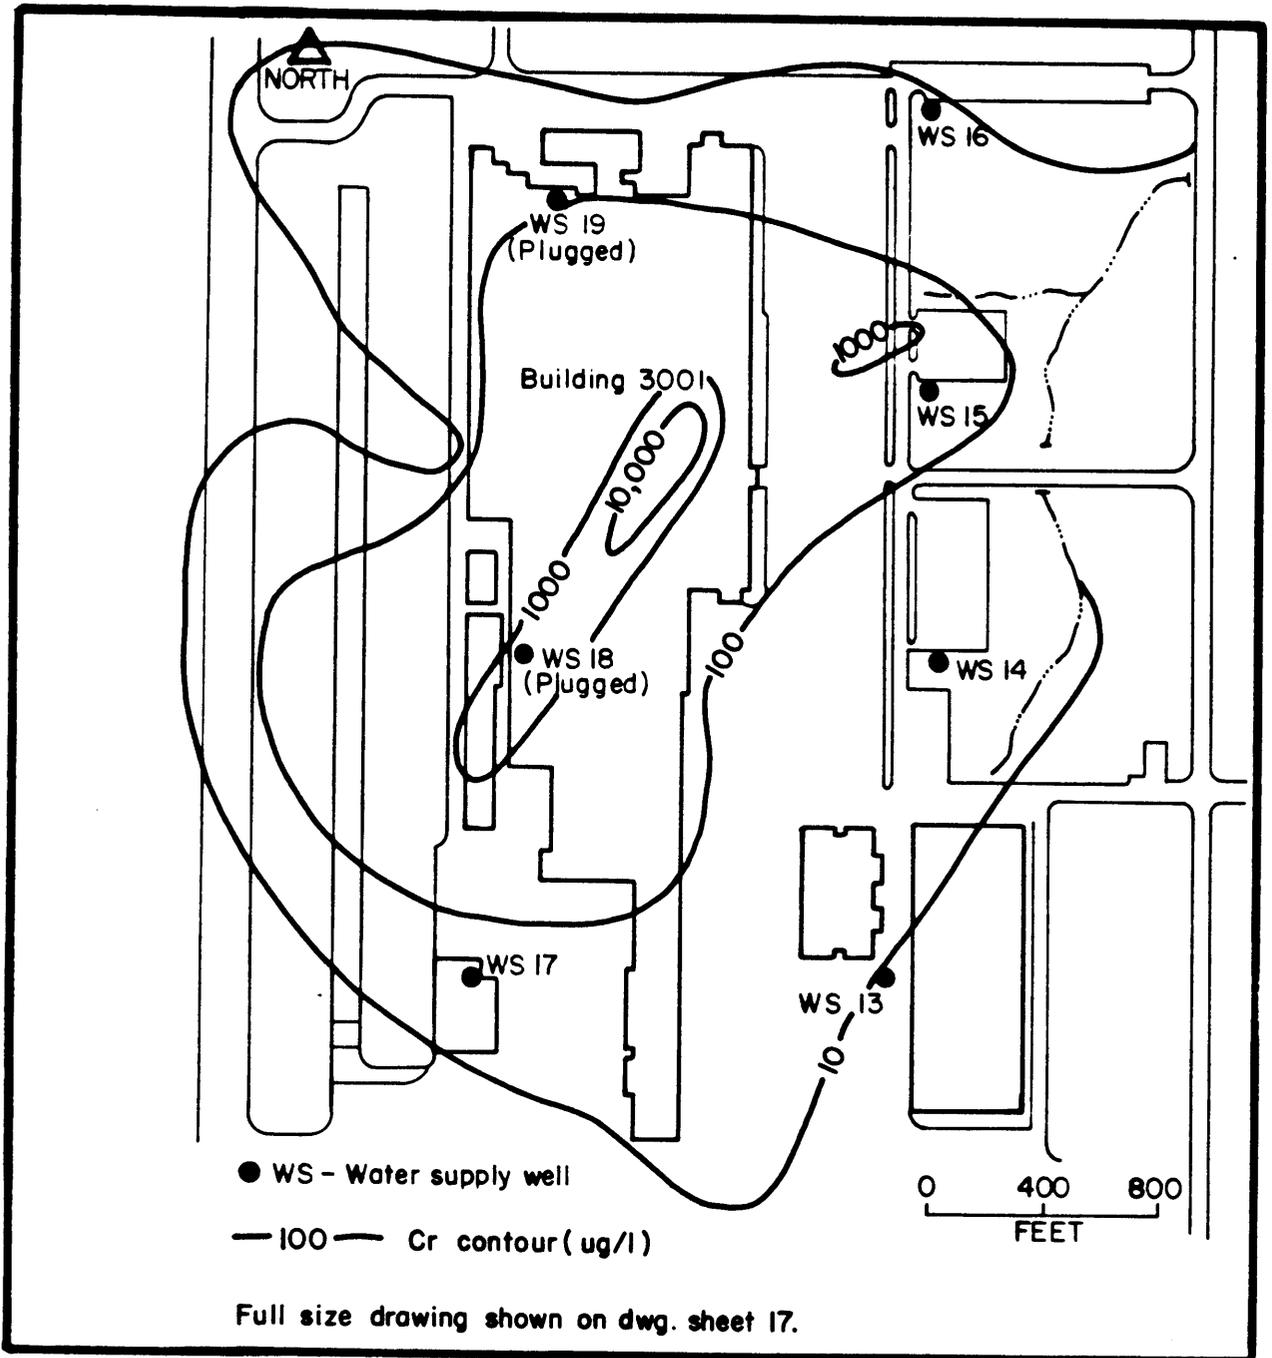
CR PLUME IN PERCHED AQUIFER
FIGURE I-6

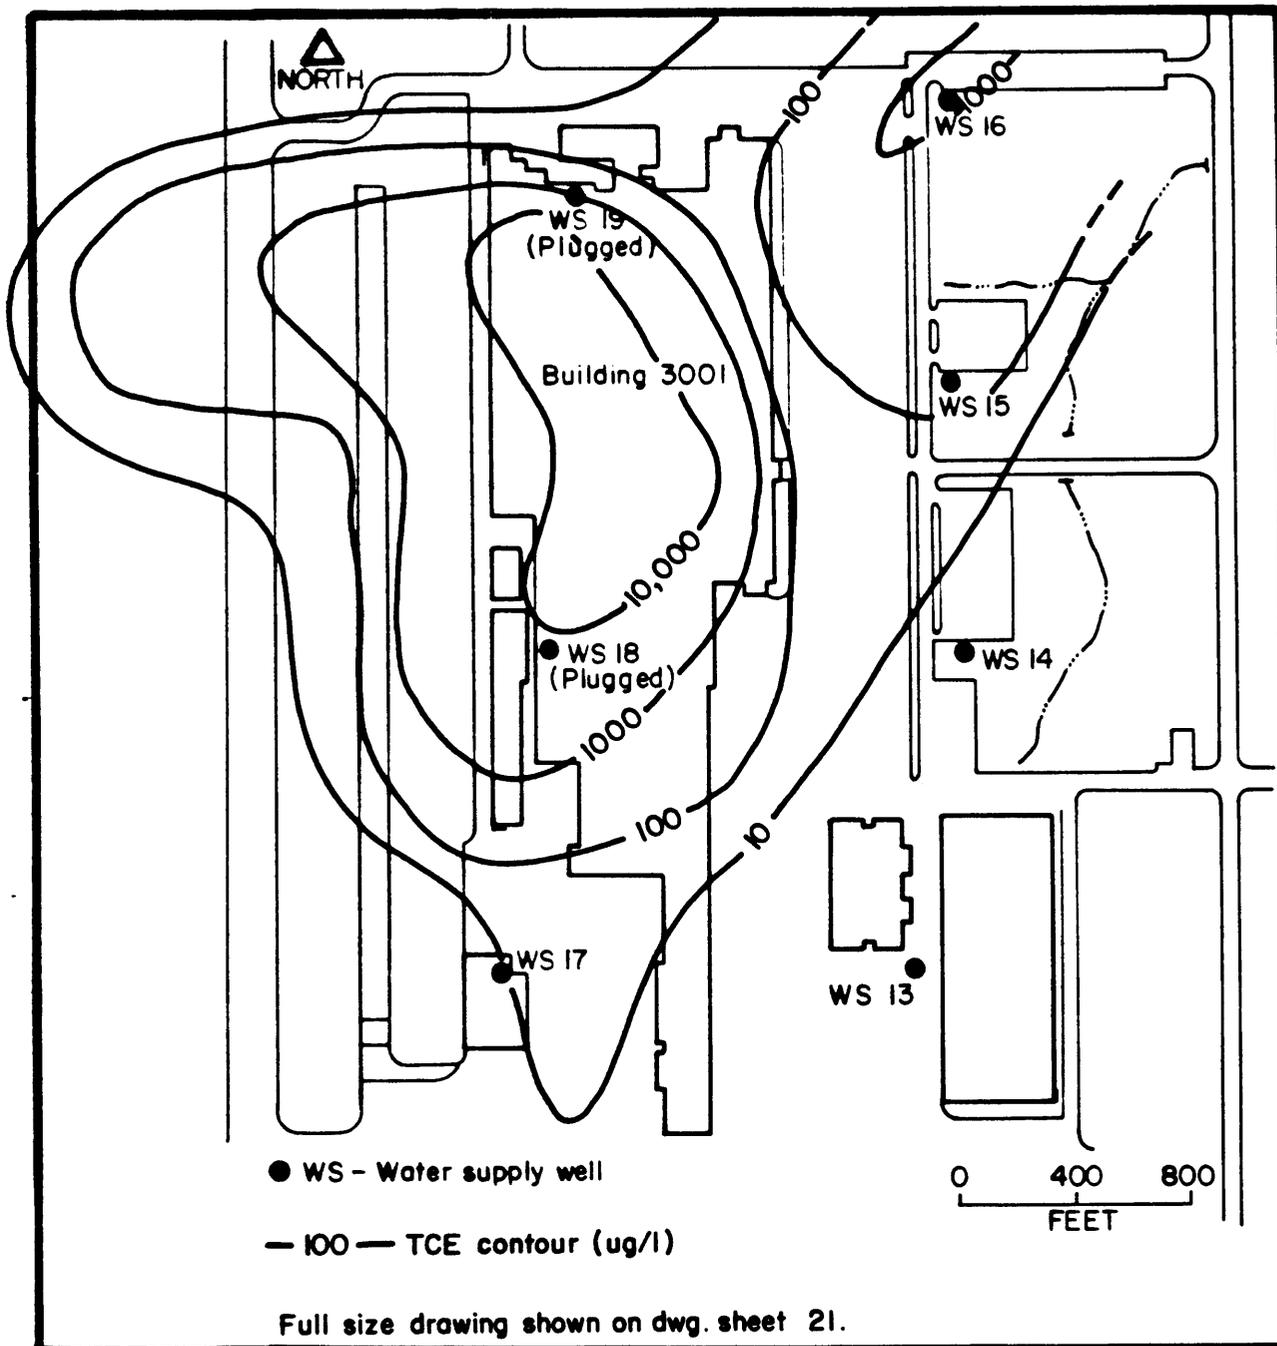
TCE PLUME IN TOP OF REGIONAL ZONE
 FIGURE I-7

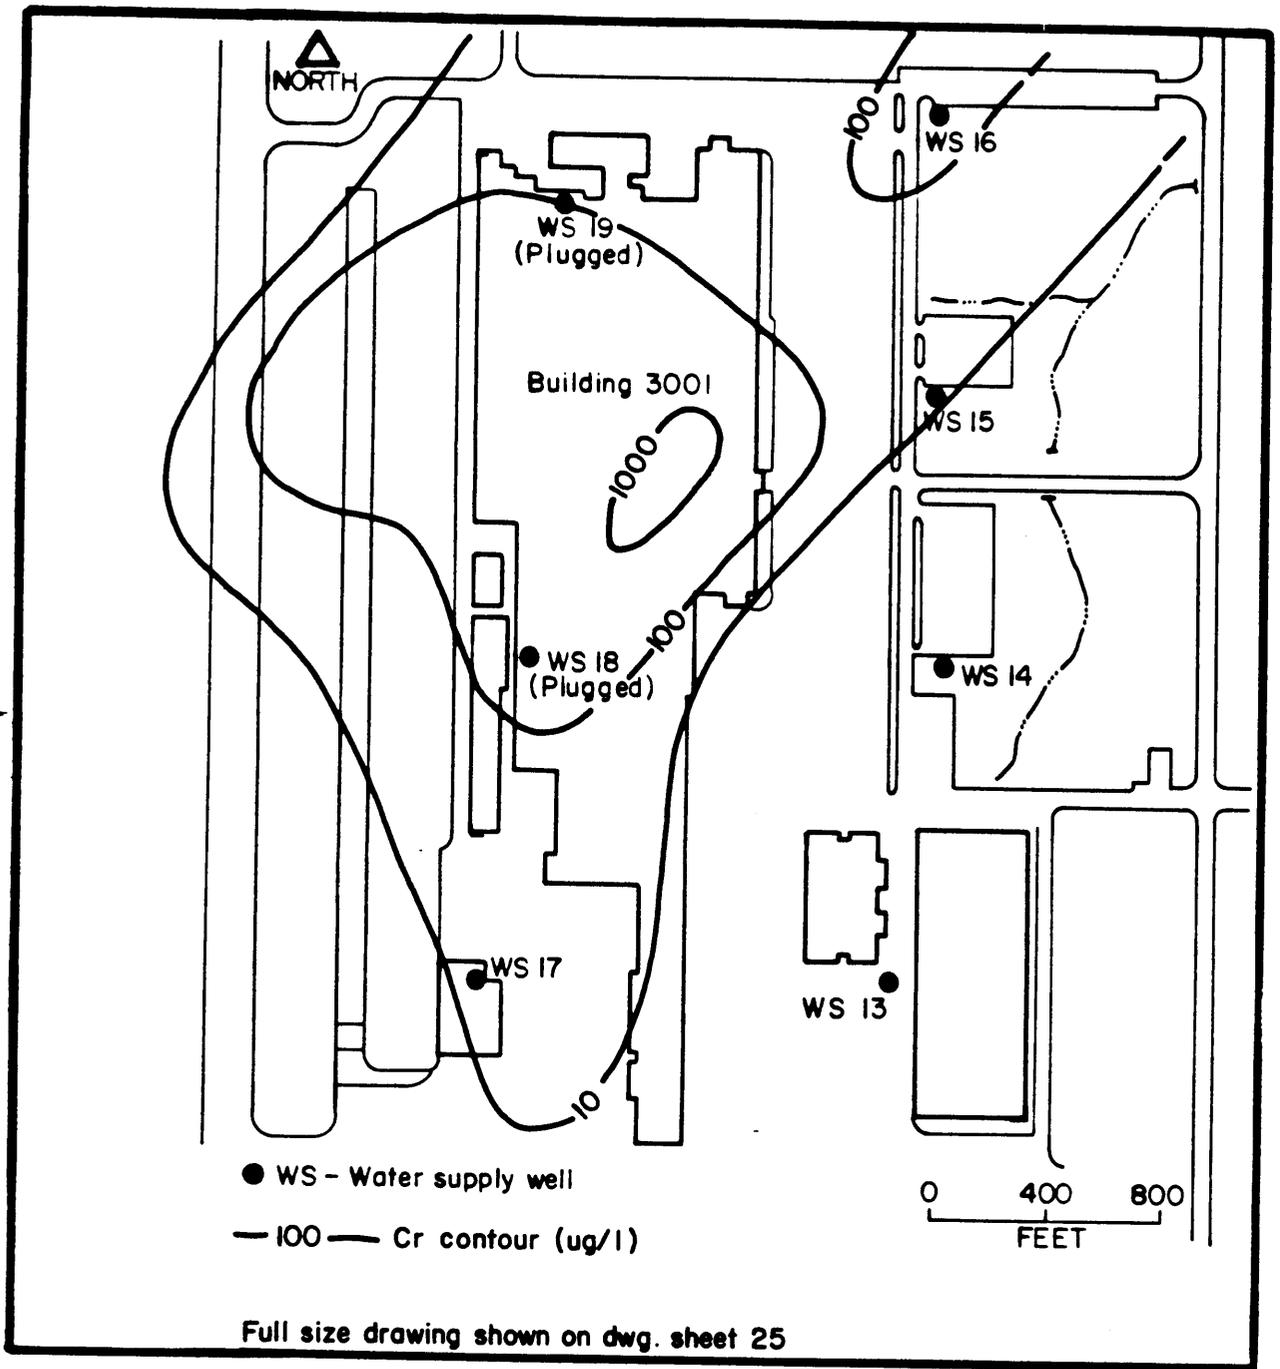
CR PLUME IN TOP OF REGIONAL ZONE
 FIGURE I-8

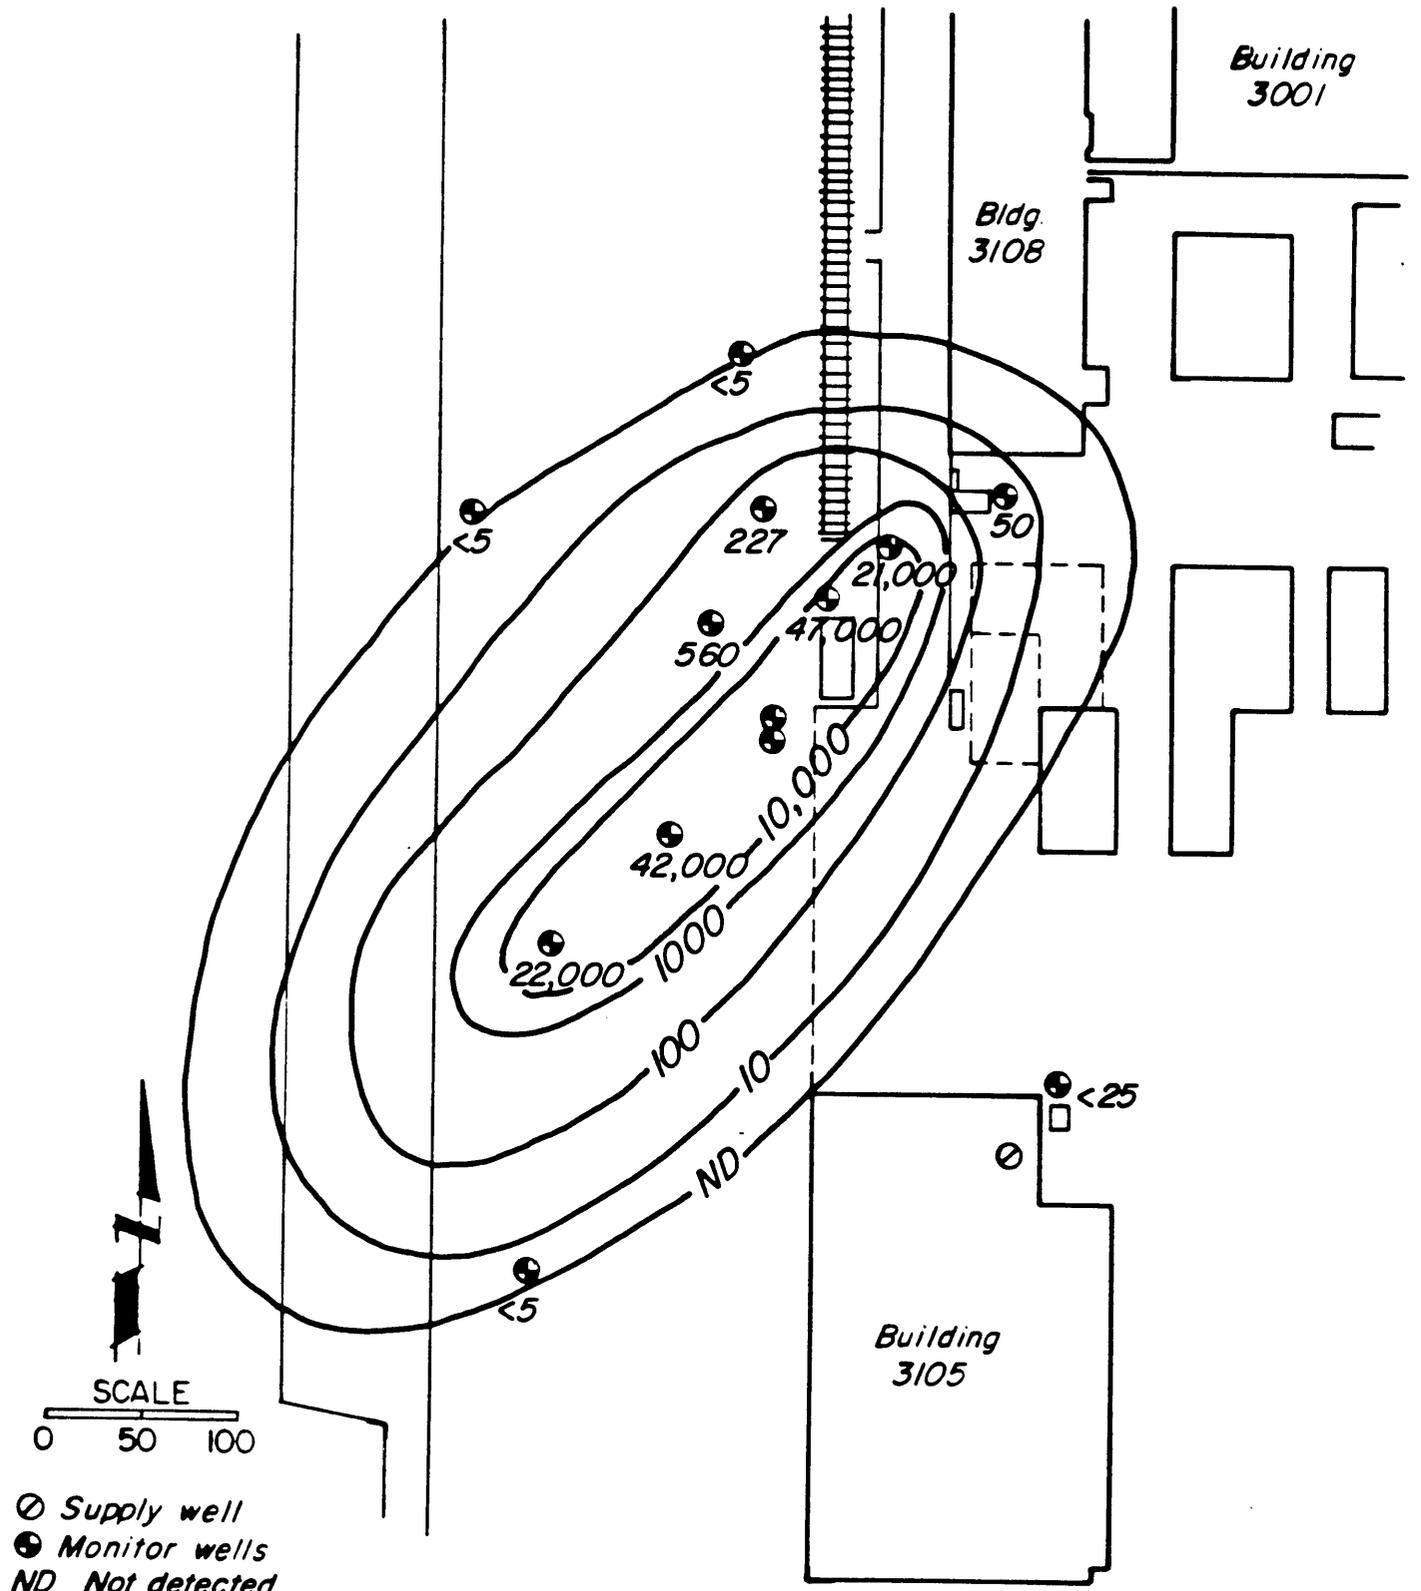
FIGURE 8-2

a) Southwest Tank Area. Toluene, benzene, and xylene were found in high concentrations at the southwest tank area. Toluene ranged from 47,000 ug/l (well M-1) to less than 5 ug/l (well 1-16) during the sampling period. The plume is moving towards the southwest, which is the direction of groundwater flow in this area. Benzene ranged from 1535 ug/l (well M-6) to 15 ug/l in a similar shaped plume. Total xylenes concentrations ranged from 130 to 5 ug/l. Figures 8-2, 8-3 and 8-4 show this tank area in greater detail with the plumes of toluene, benzene, and xylene, respectively. The organics are the result of fuel leaks. As shown by the figures, the plume shapes indicate that the source is in the vicinity of the 7 abandoned fuel tanks (tank numbers 3140 - 3144, and 3146-3147). The plumes of toluene and benzene extend to the west beyond wells 1-16 and 1-17. An additional well cluster will be installed in the location shown (well 1-45) on drawing 1 to further define the extent of this contaminant spread.

TOLUENE CONCENTRATIONS
(ug/l)
SOUTHWEST TANK AREA

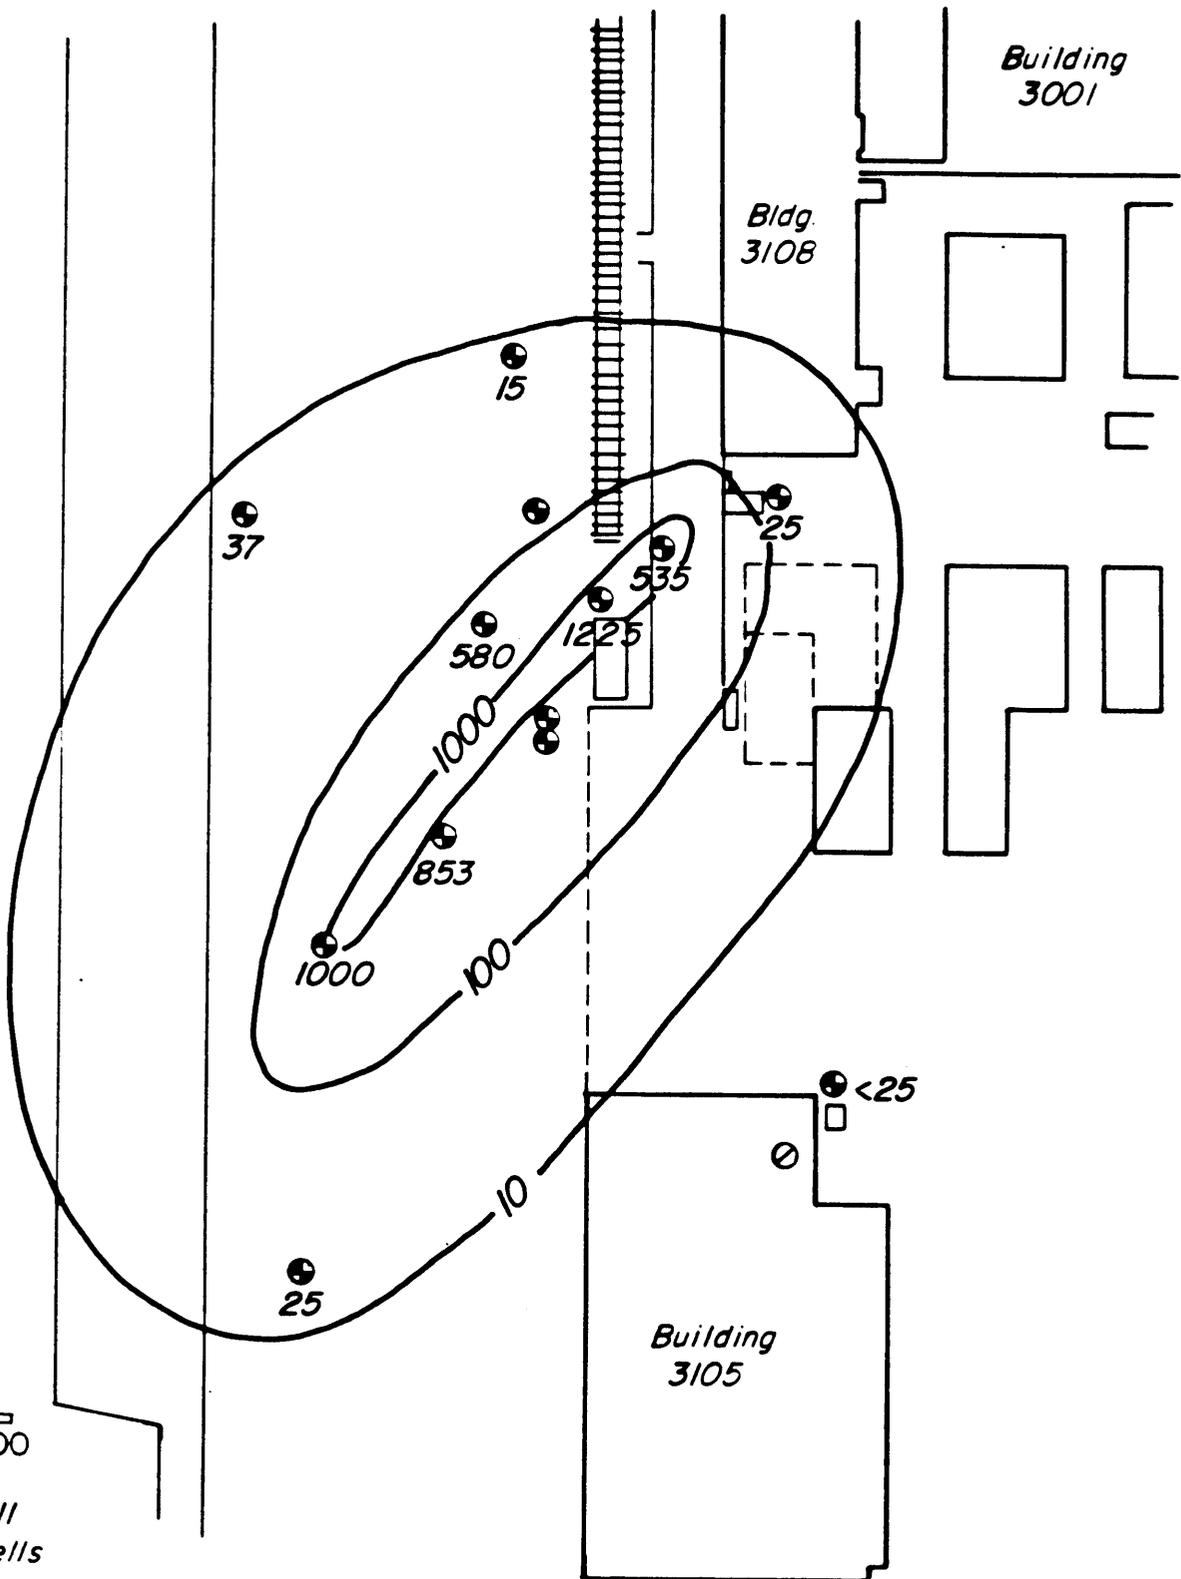
FIGURE 8-3

BENZENE CONCENTRATIONS
(ug/l)
SOUTHWEST TANK AREA

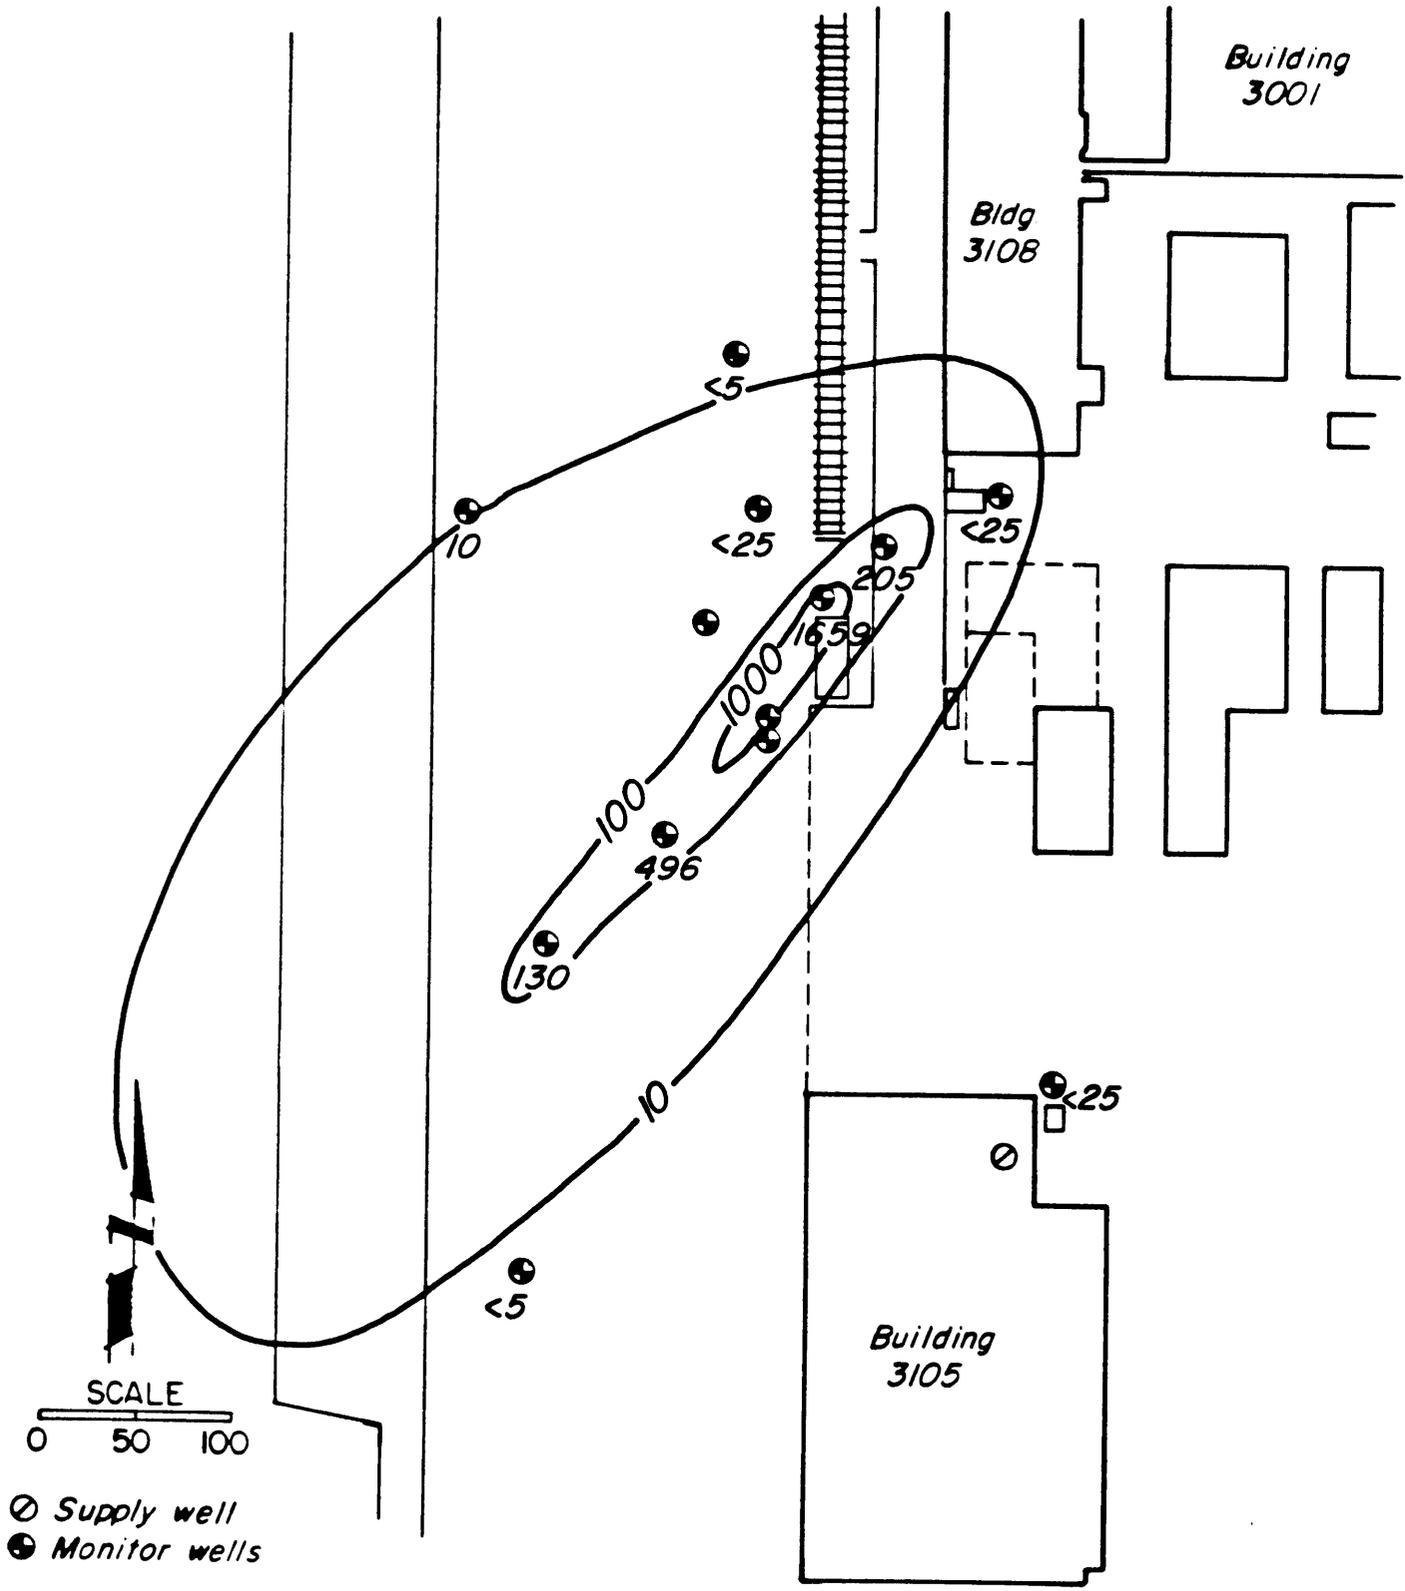
FIGURE 8-4

TOTAL XYLENES CONCENTRATIONS
(ug/l)
SOUTHWEST TANK AREA

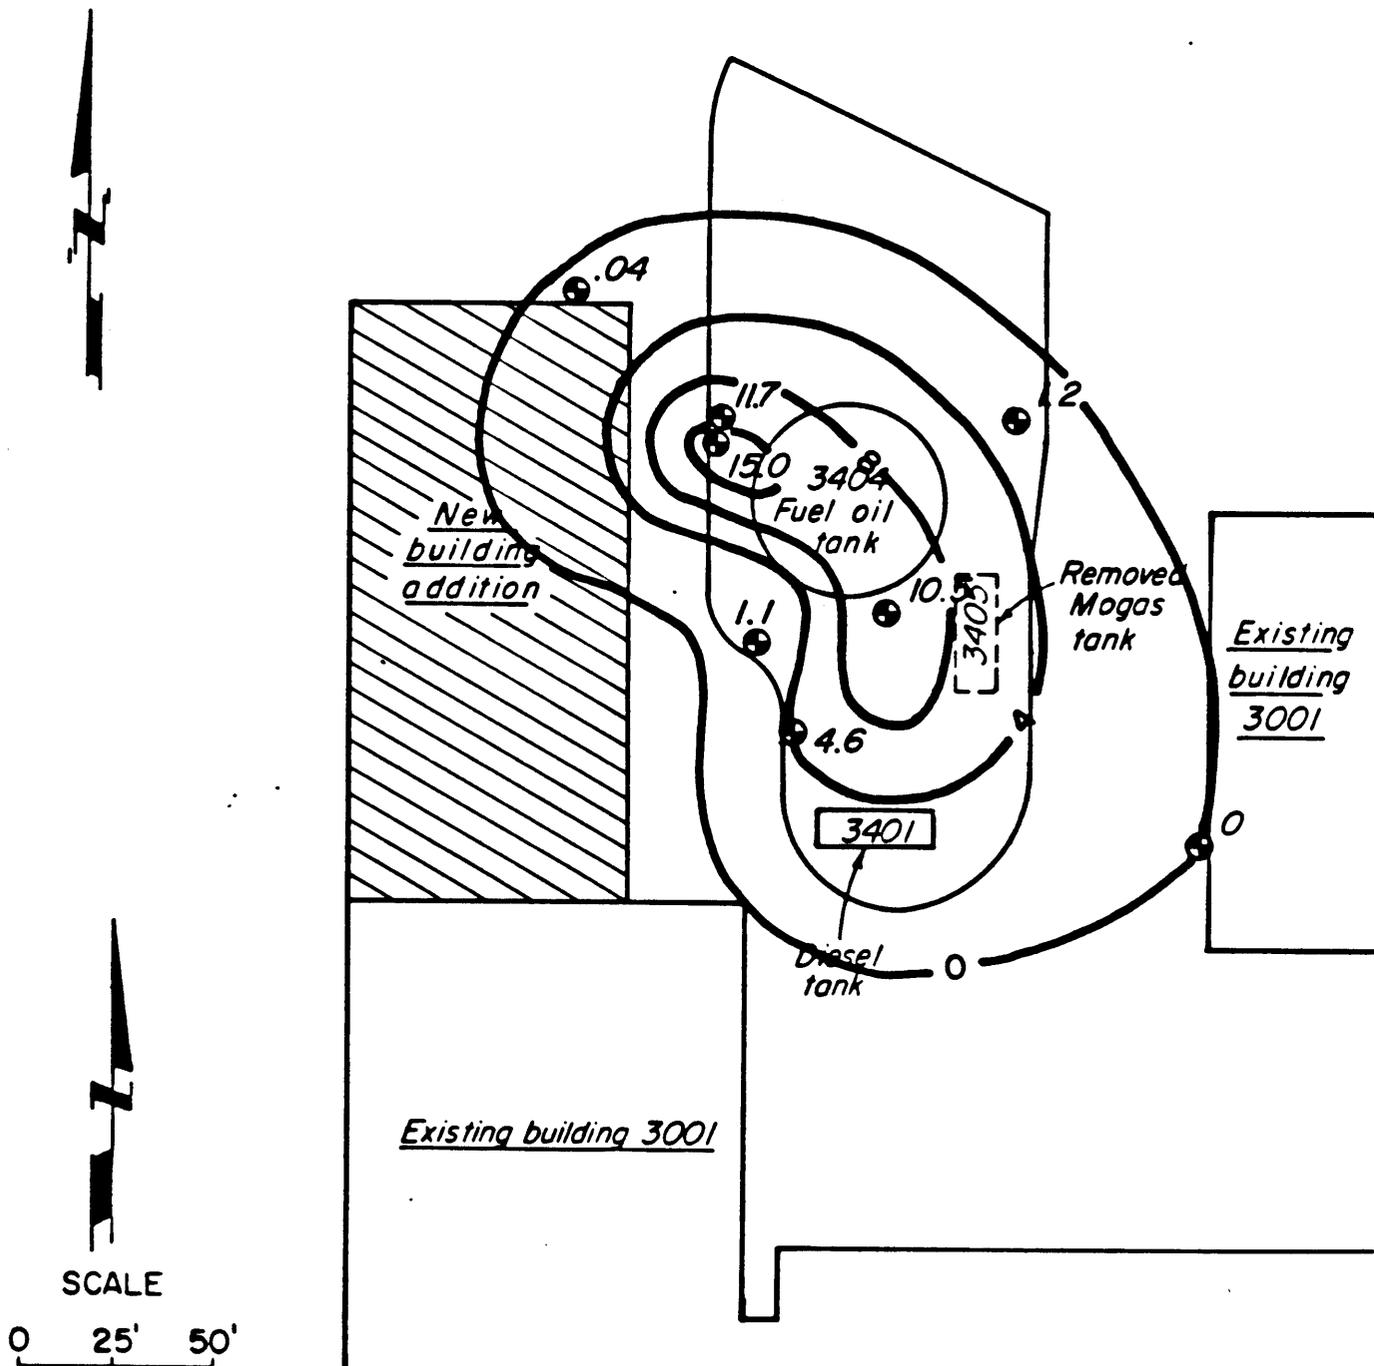
FIGURE 8-5

The upper soils at the north tank area contain fuel contamination, primarily fuel oil. Significant contamination was not observed in the upper soils at the southwest tank area.

FUEL ISOPACH
NORTH TANK AREA
