Building 3001 Remedial Investigations Volume I - Report

TINKER AIR FORCE BASE Installation Restoration Program

TINKER AIR FORCE BASE
INSTALLATION RESTORATION PROGRAM
PROJECT NO. WWYK86-311
SITE NO. TINKER 01

PREPARED BY:
U.S. ARMY CORPS OF ENGINEERS
TULSA DISTRICT

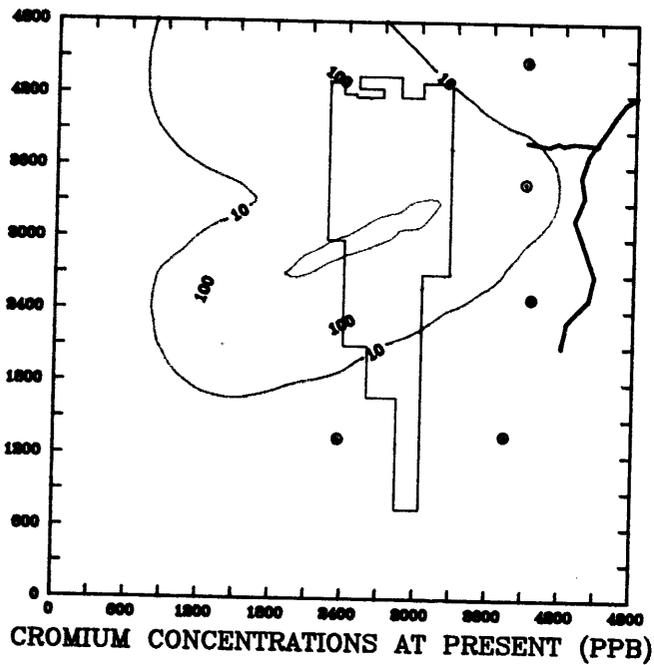
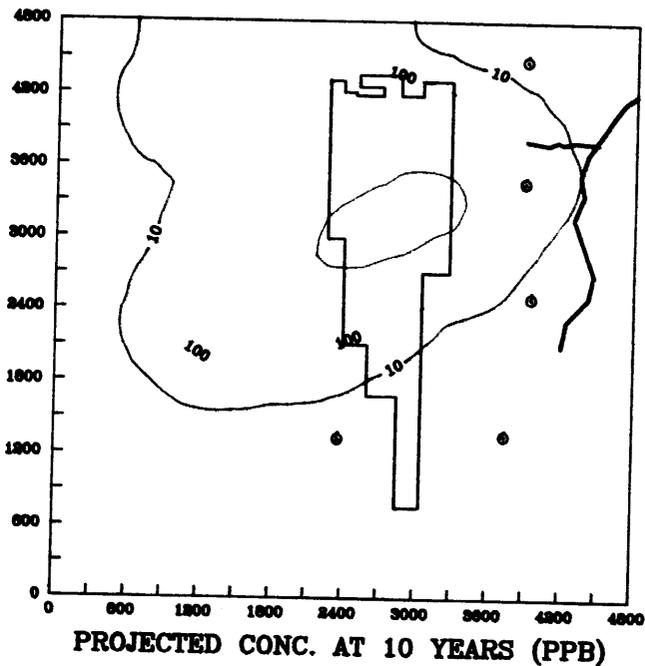
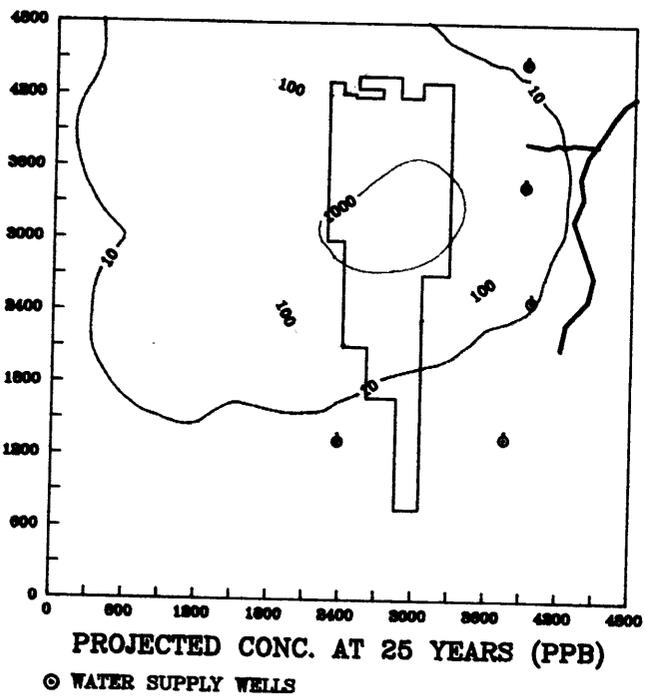
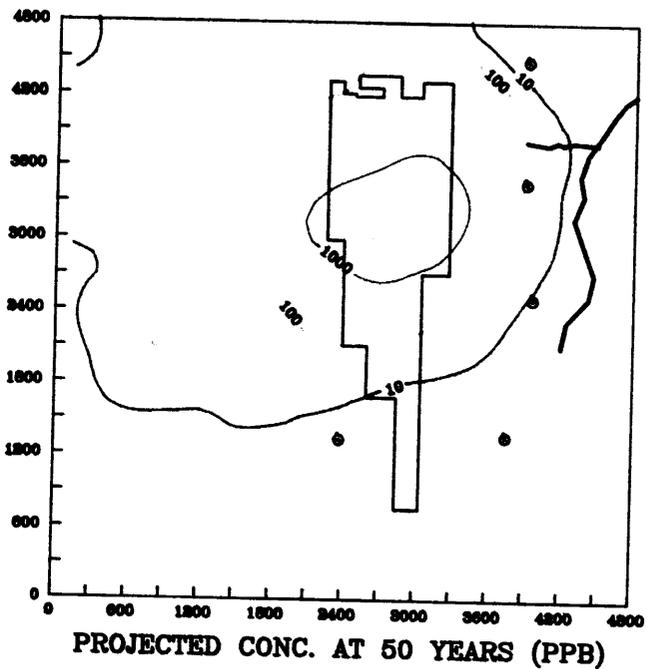
FIGURE 8-20

The source of contamination is the top of the regional zone, where vertical migration has taken place. Vertical migration rates of approximately 4 to 6 feet per year are estimated. The horizontal plume migrations were simulated over time periods of 10, 25, and 50 years as shown in figures 8-20 and 8-21. The modeling in this zone was also done assuming additional contamination was vertically migrating into and out of the zone and no contaminated water was being collected. Both plumes are moving to the west in the direction of groundwater flow. The migration rates are approximately 10 feet per year. Over the entire 50 year period the contaminants remain within the Base boundaries with the highest concentrations beneath the buildings. Contamination continues to slowly spread vertically towards the deeper zones at approximately 4 to 6 feet per year.

TCE PLUMES IN THE REGIONAL ZONE

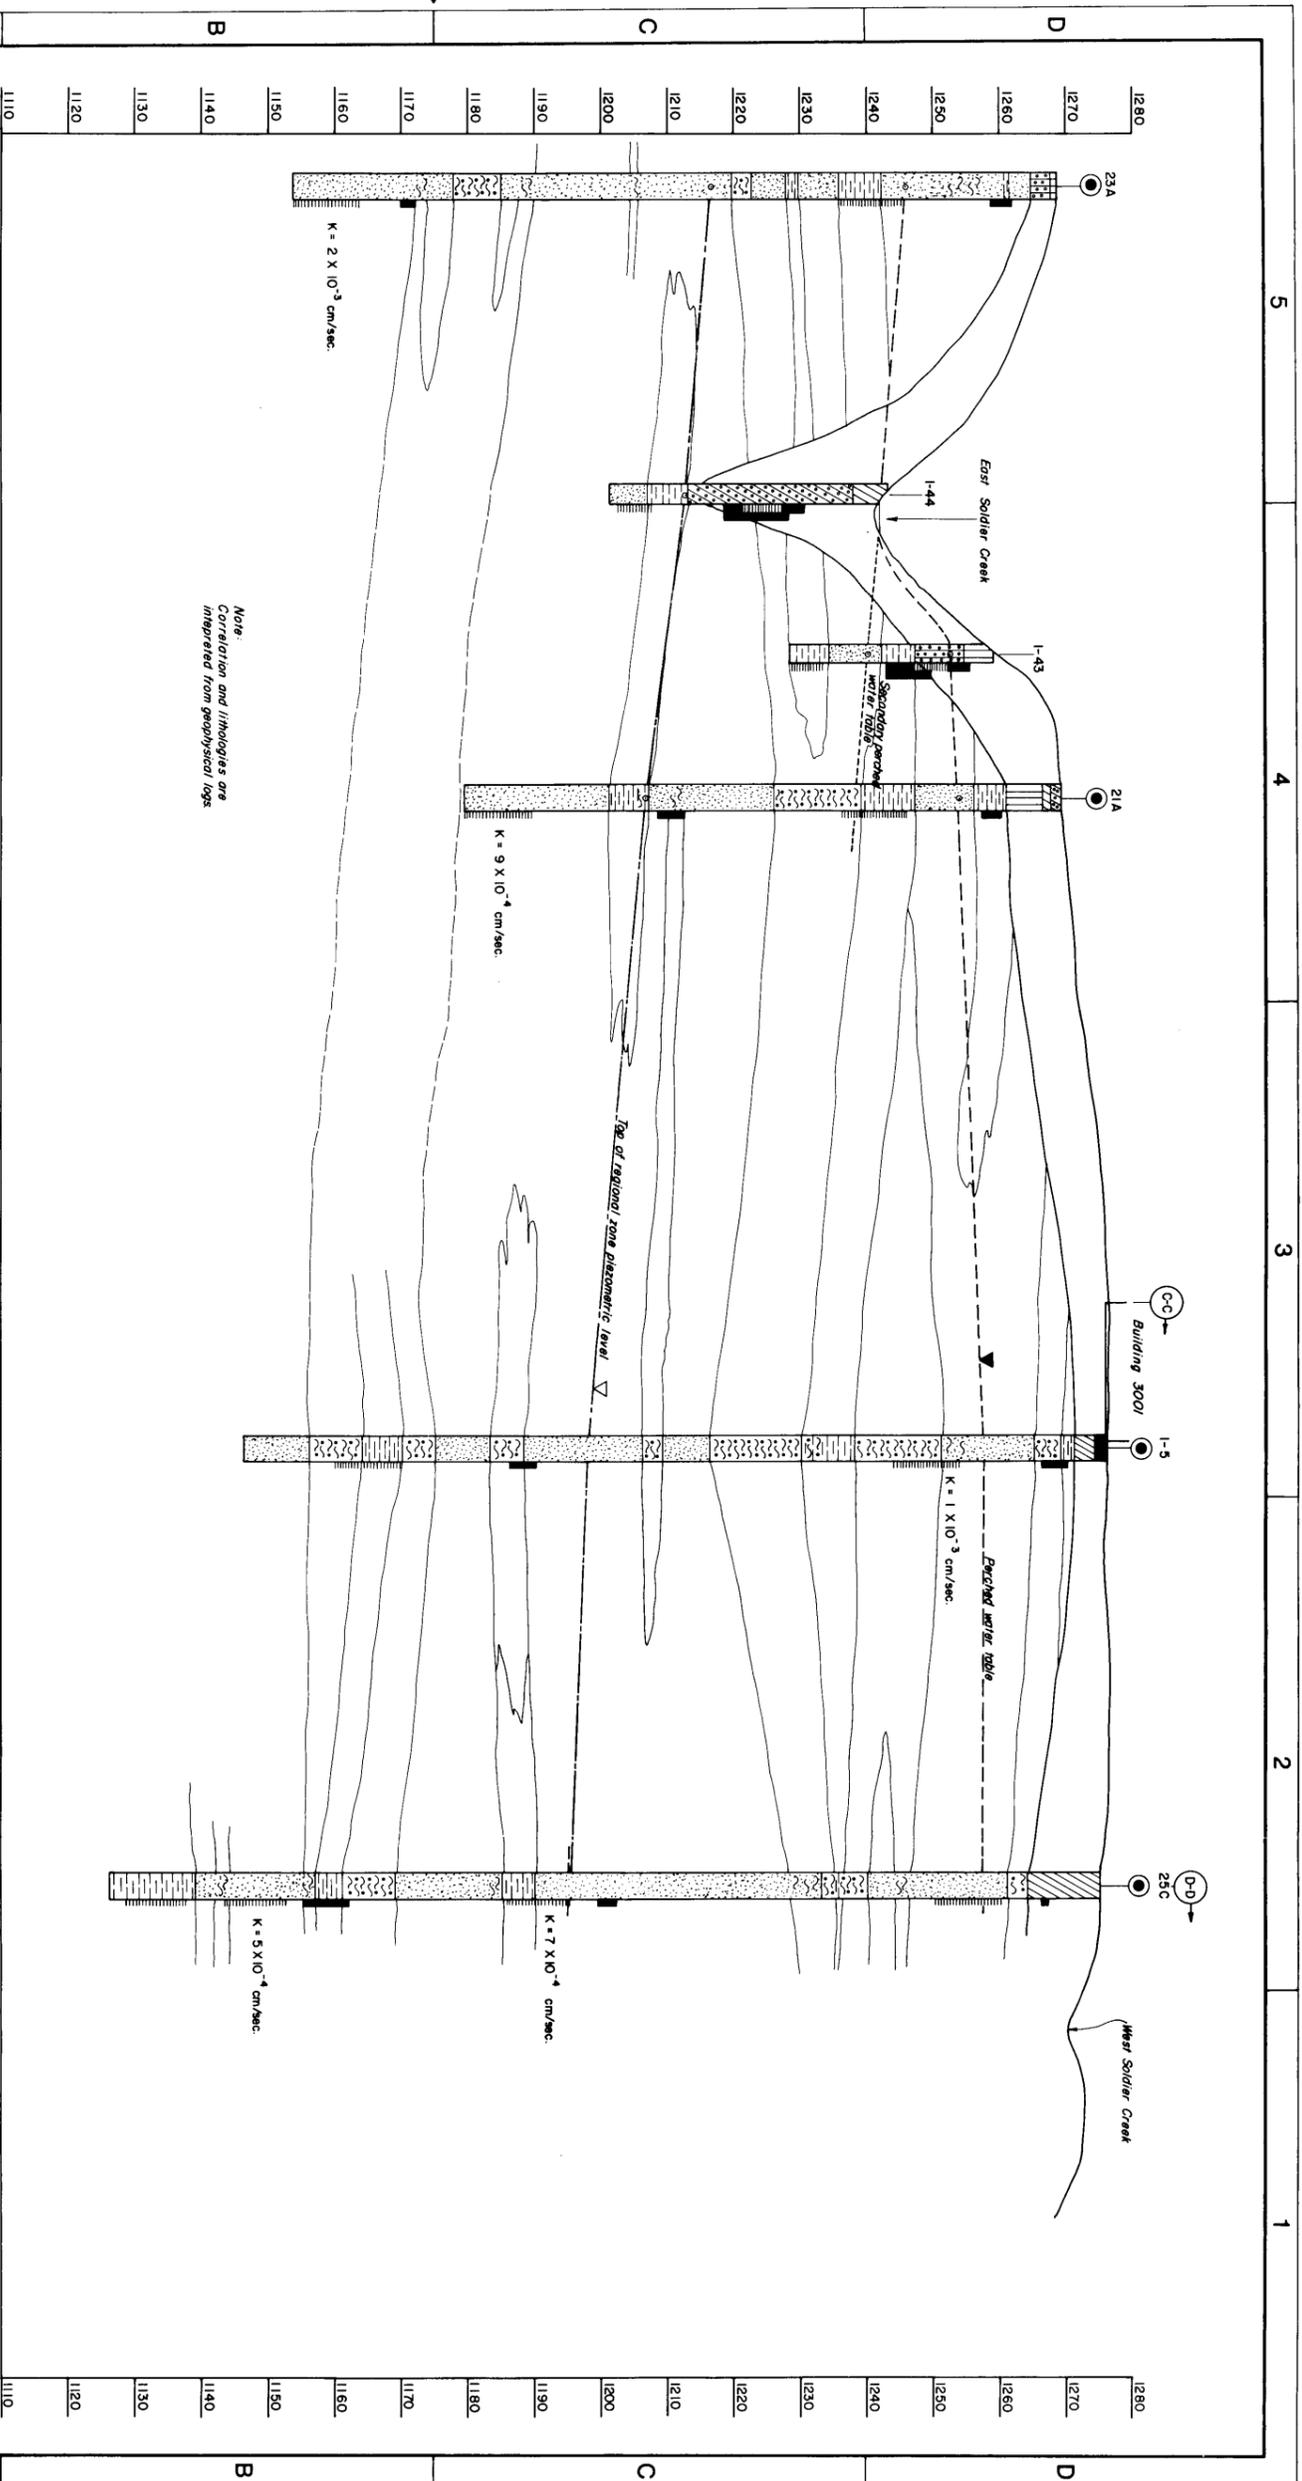
SECTION B-B

Four geologic sections (A-A through D-D), drawings 3 through 6, have been constructed to illustrate the geology and groundwater conditions at the site. Section A-A and B-B are east-west sections through the building and East Soldier Creek and West Soldier Creek, and sections C-C and D-D are north-south sections. The locations of these sections are shown on drawing 1. Drawings 7 through 9 are potentiometric surface contour maps of the perched aquifer, the top of the regional aquifer, and the regional aquifer. These drawings show the stratigraphy and the potentiometric surfaces, and their relationship to the surface drainages. East Soldier Creek is partially fed by perched water, and has little effect on any of the deeper water zones. Drawing 7A shows the perched groundwater contours overlain by the utility lines at the site. The perched water is slightly mounded under the building and west of the building from leaky storm drains and West Soldier Creek. The depth to this perched water is about 15 feet. The top of regional and regional zones are very similar to each other and flow to the west and southwest. The water-bearing zones of the Garber-Wellington are influenced by shale confining beds, and show a vertical downward gradient.
