(NAVY) NAVAIR 17-15-50.3
(ARMY) TM 38-301-3
(AIR FORCE) T.O. 33-1-37-3
(COAST GUARD) TO 33-1-37-3

JOINT OIL ANALYSIS PROGRAM MANUAL

VOLUME III

LABORATORY ANALYTICAL METHODOLOGY AND EQUIPMENT CRITERIA (AERONAUTICAL)

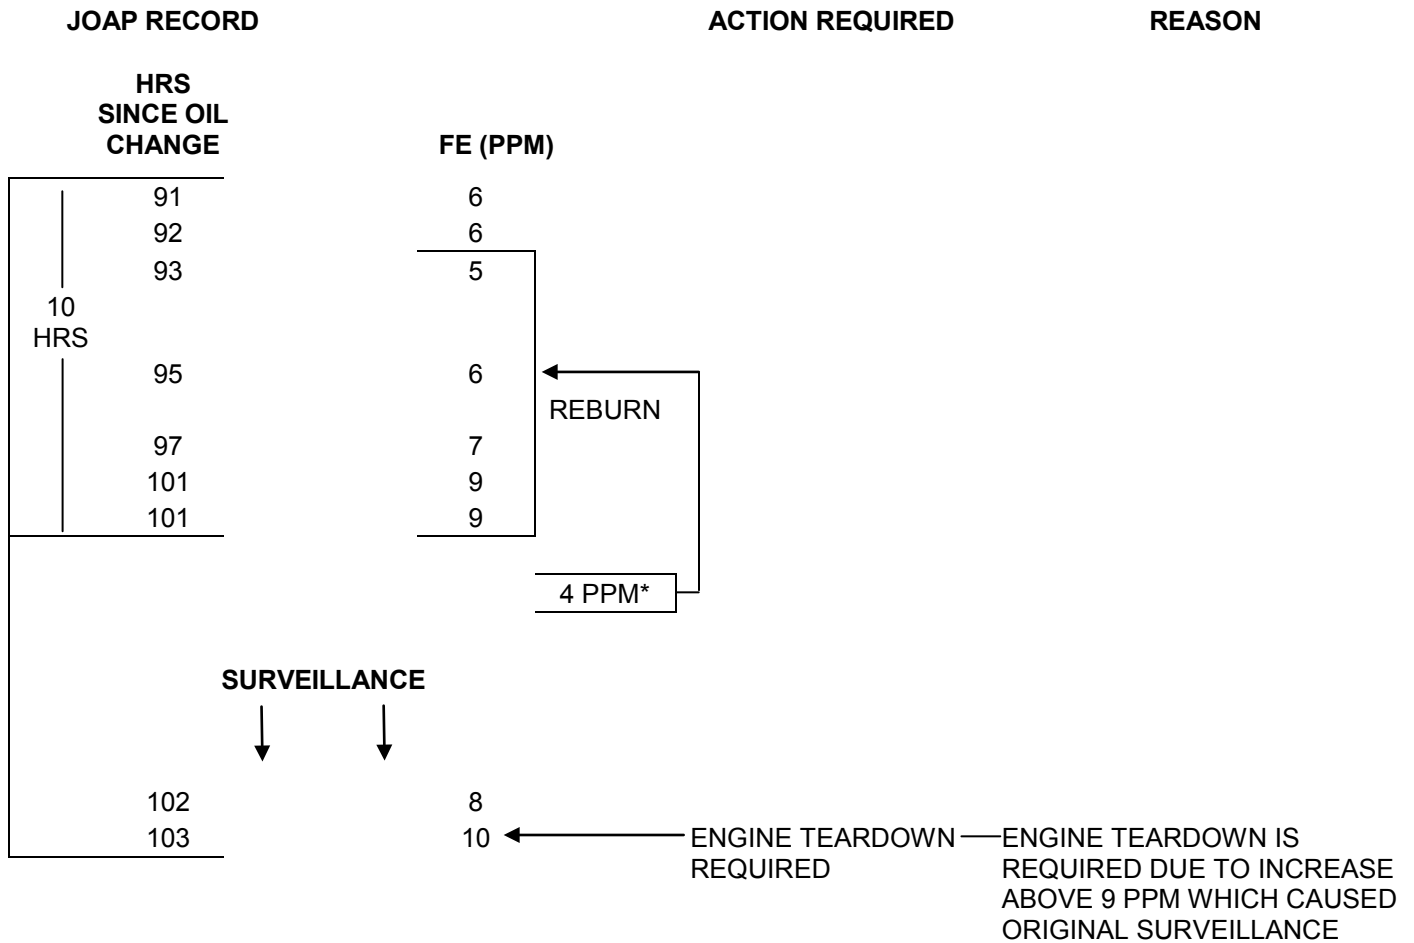
EXAMPLE: PRIOR TO SURVEILLANCE
 (FOR FE INCREASE IN 10 ENGINE HOURS)

* 4 PPM or greater using JOAP Atomic Emission.
