(NAVY) NAVAIR 17-15-50.3
(ARMY) TM 38-301-3
(AIR FORCE) T.O. 33-1-37-3
(COAST GUARD) TO 33-1-37-3

TECHNICAL MANUAL
JOINT OIL ANALYSIS
PROGRAM MANUAL

VOLUME 3

LABORATORY ANALYTICAL METHODOLOGY AND
EQUIPMENT CRITERIA (AERONAUTICAL)

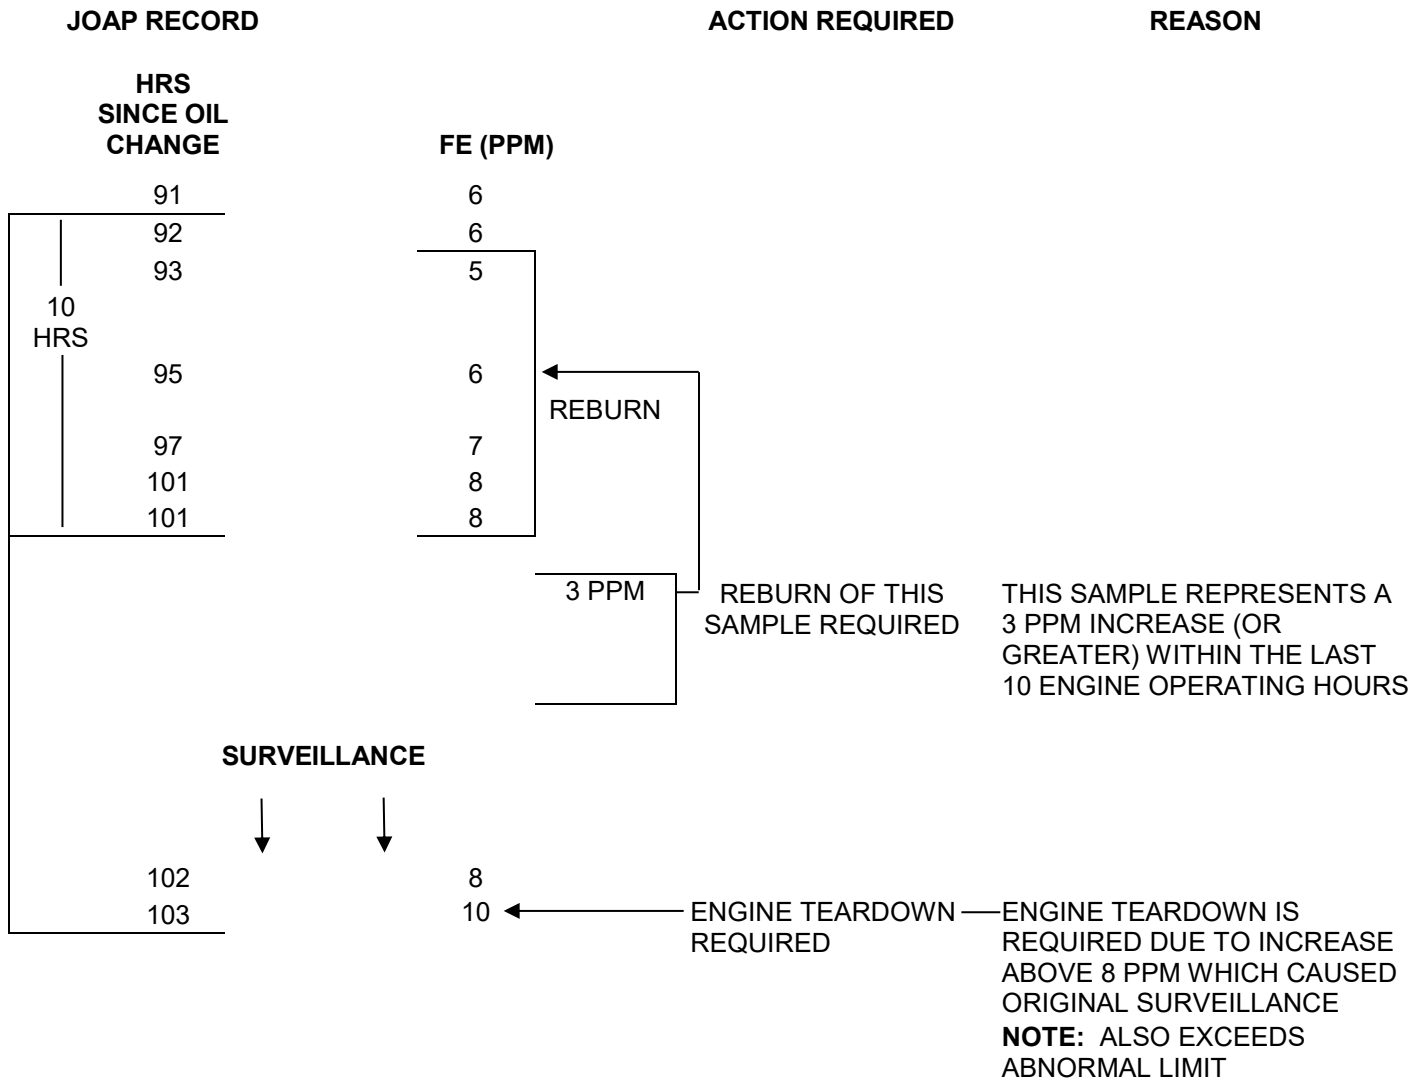
EXAMPLE: PRIOR TO SURVEILLANCE
 (FOR FE INCREASE IN 10 ENGINE HOURS)
